This guide has been produced to assist Contractors and Consultants (in particular the RPEQ qualified Consulting Engineer for the Development) in arranging for the correct acceptance tests to be completed on all new works.

### A1 General Information

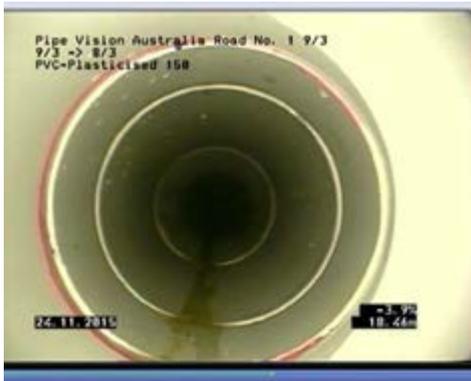
FIG A1.1: Example of good quality footage – acceptable

All CCTV inspection is to be clear and sharp so that review of the newly constructed works can be completed. CCTV inspection that is of poor resolution, out of focus, and/or has poor lighting is unacceptable. This type of footage will be rejected, and the contractor will be required to have the inspection completed again at their cost.

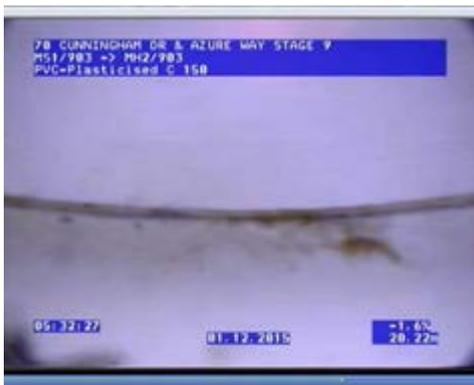
FIG A1.3: Example of poor quality footage of a joint - not acceptable

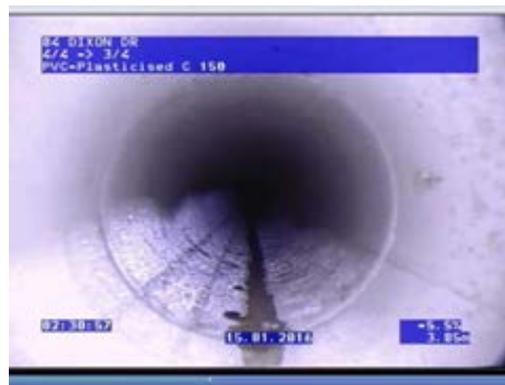
FIG A1.4: Example of poor quality footage of a joint - not acceptable

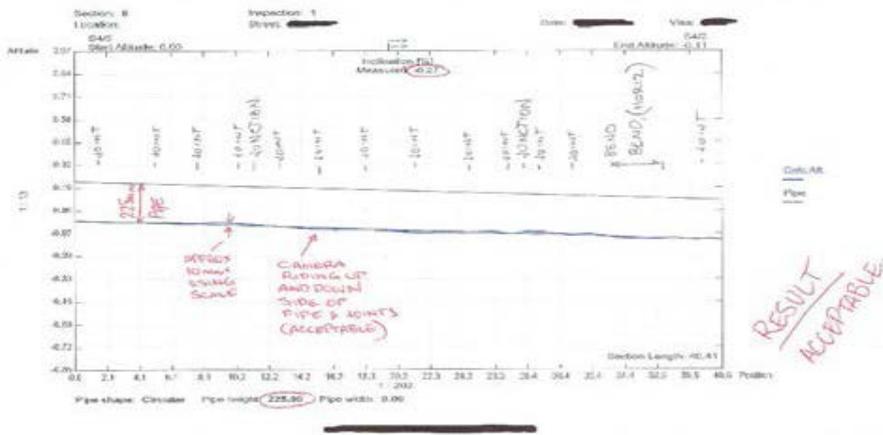
FIG A3.1: Example of how to review an inclination report – pipe acceptable

The SEQ Code (Amendment to WSA02) requires the CCTV inclinometer to be accurate to  $\pm 1\%$  (\*). The consulting engineer (RPEQ) for the development will determine from the CCTV inclination report and any survey information (as constructed information) whether the longitudinal grade between maintenance structures conform with the acceptable tolerances and the relevant tables in WSA02 adjusting to suit the inclinometer accuracy. This cannot be determined by the invert levels provided in the as constructed survey information at each maintenance structure, but can be determined where the as constructed survey information provides progressive construction levels along the pipe at suitable intervals and at the top of each junction.

Description	Approved Design Grade	Design with inclinometer Accuracy (*)	Inclination Grade	Grade Tolerance	Acceptable (Y/N)	Comment
Line 1/22 – 12/15	5.7%	4.7 % to 6.7%	5.8%		Y	
Line 1/22 – 12/15	5.7%	4.7 % to 6.7%	7.0%	$\pm 20\%$	Y	Review considered accuracy of inclinometer plus tolerance
Line 1/22 – 12/15	5.7%	4.7 % to 6.7%	Varies due to extra vertical bend being installed	$\pm 20\%$	N	Permissible change required for bend and change of grade
Line 1/22 – 12/15	5.7%	4.7 % to 6.7%	12.5%	$\pm 20\%$	N	Permissible change required for change of grade OR if error with inclination new CCTV required

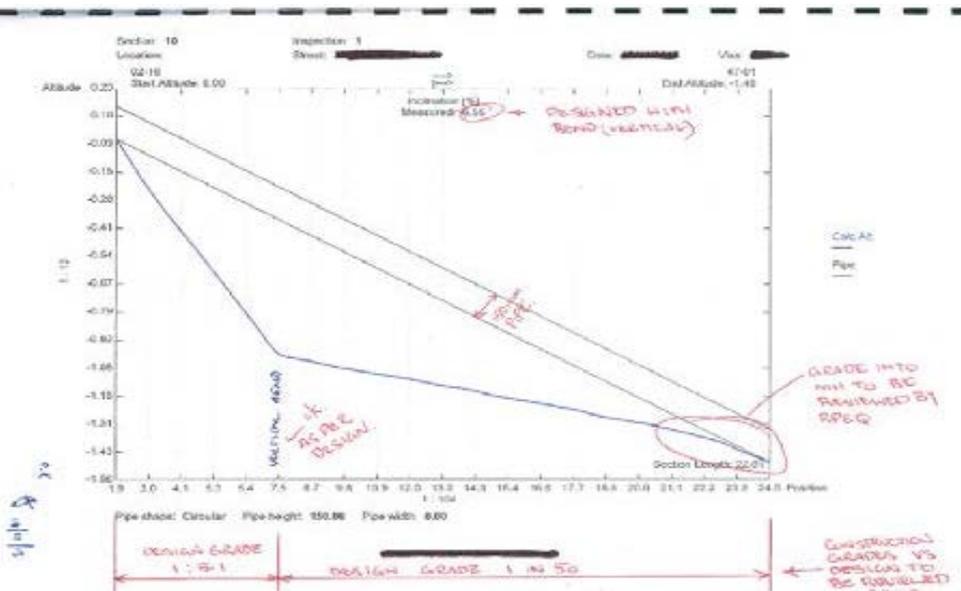
FIG A3.2: Example of how to review an inclination report – consulting engineer (RPEQ) to determine if acceptable

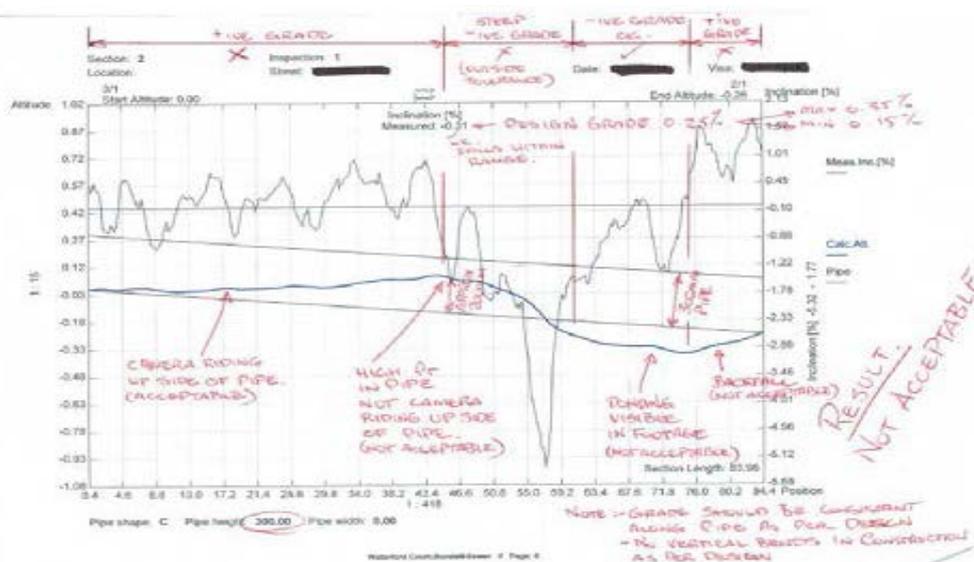
FIG A3.3: Example of how to review an inclination report – pipe not acceptable

No backfall is permitted along a pipe but Unitywater will allow for short sections less than 500mm long at joints.

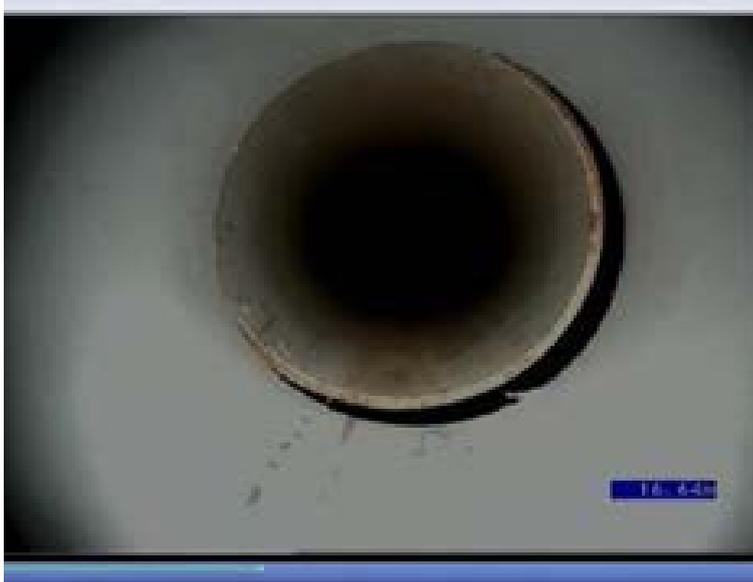
FIG A4.1: Example of collapse at a joint – not acceptable

The *Conduit Inspection Reporting Code WSA05* states a maximum allowable percentage for any collapse in a pipe or junction. Any collapse above this is not acceptable. Unitywater will not accept collapsed pipes or junctions under any circumstance.

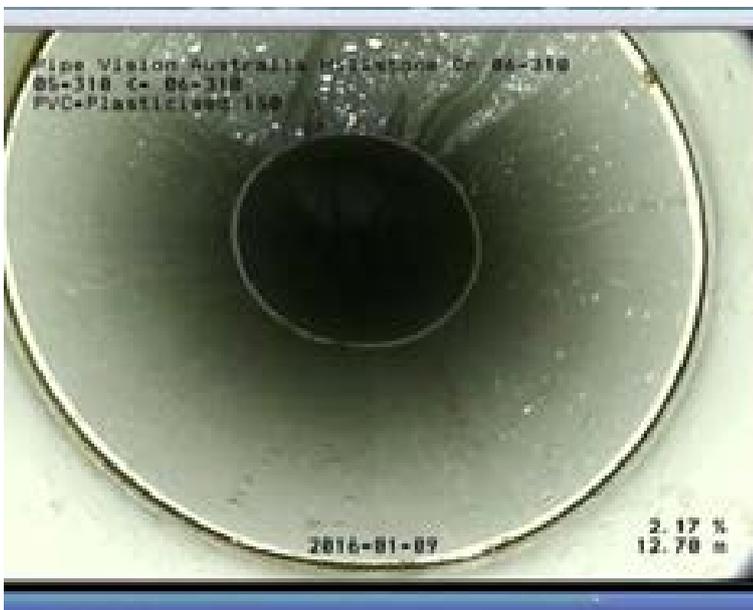
FIG A4.2: Example of deformation (ovality) – not acceptable

The *Conduit Inspection Reporting Code WSA05* also provides the percentage of circumference deformation (ovality) allowable for newly installed sewer mains.

Where circumference deformation (ovality) is evident on the CCTV footage, and a deflection (ovality) test for the line has been completed more than 2 weeks prior to the CCTV investigation, the Contractor shall be required undertake a new ovality test to prove that the joint is acceptable. Where a successful deflection (ovality) test for the line has been completed within 2 weeks prior to the CCTV investigation the consulting engineer (RPEQ) will provide a copy of both test results and include the location in the written report as a non-defect.

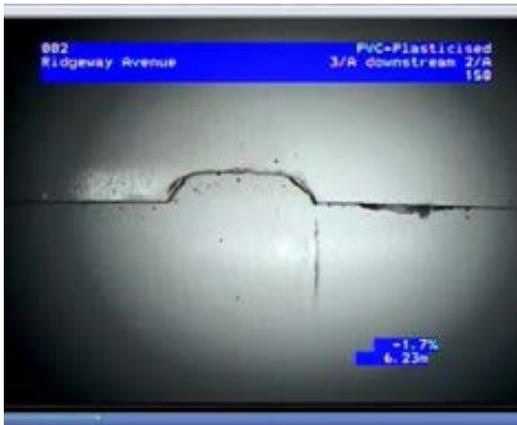
FIG A5.1: Example of a defect at a joint – not acceptable

- cracks, tears, burs, indentations or deformations resulting from bad construction techniques,
- end of pipes cut on site not cut square and cleaned in accordance with manufacturer's recommendations,
- foreign matter caught within the joint during installation,
- rolled rubbers protruding from the joint.

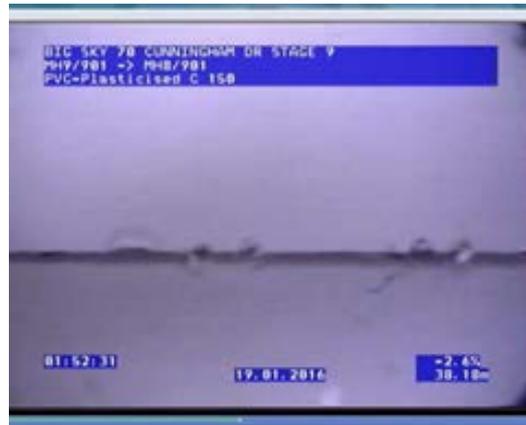
FIG A5.2: Example of defects at a joint – not acceptable

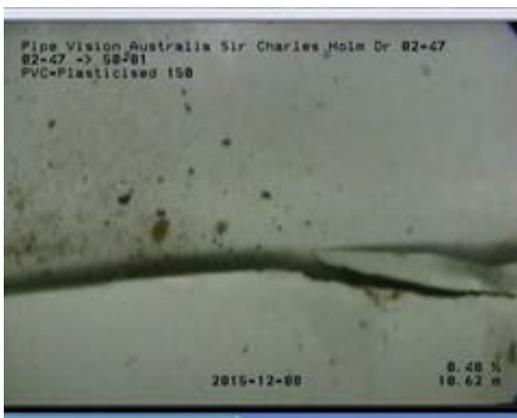
FIG A5.3: Example of a defect at a joint – not acceptable

All manhole/pipe interface joints and rocker pipes must be included in the CCTV investigations so that the joints can be reviewed. The joints and rocker pipes shall be in accordance with the applicable SEQ Code Standard drawing.

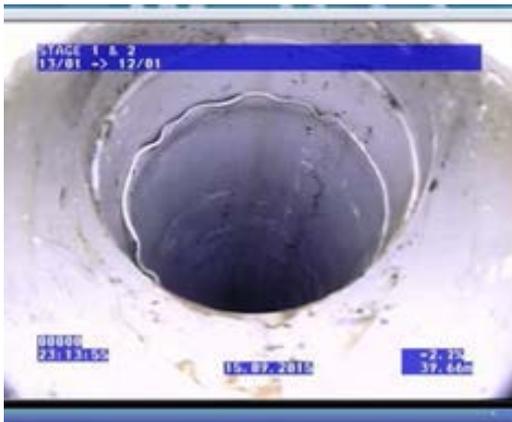
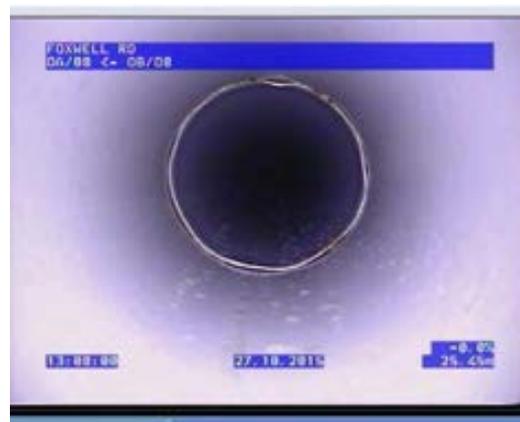
FIG A5.4: Example of a defective house junction – not acceptable FIG A5.5: Example of a defective joint – not acceptable

Heating of pvc pipes is not permitted under any circumstance. The process of heating pipes can result in damage to the pipe such as deformation of the socket or spigot.

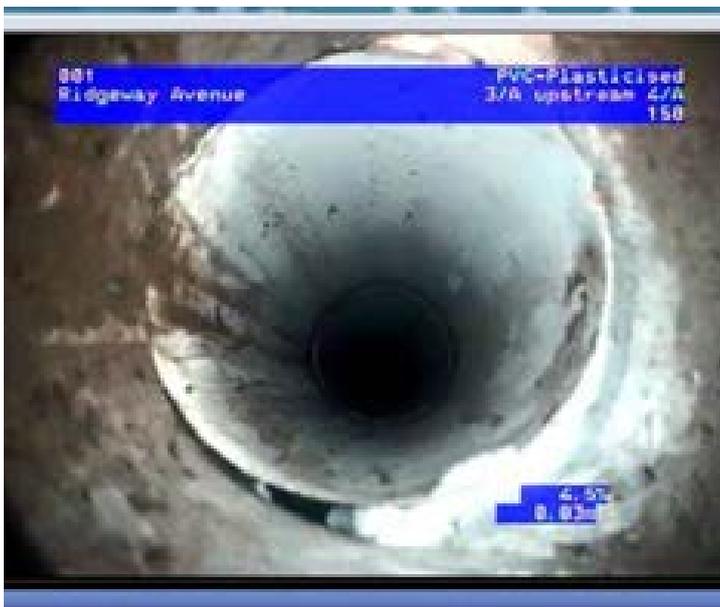
FIG A5.6: Example of a defect at the manhole/pipe interface joint – not acceptable

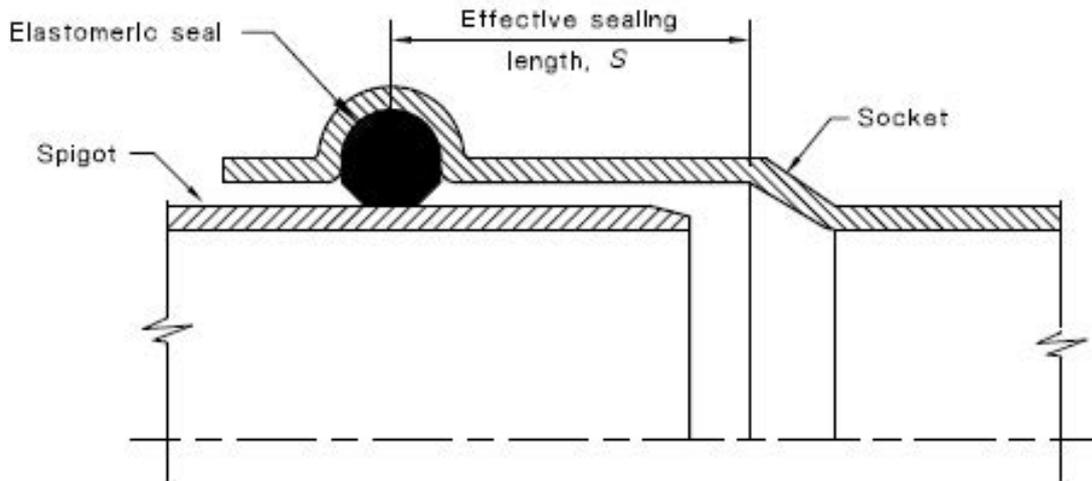
FIGURE 7.1 TYPICAL ELASTOMERIC SEAL JOINT ON PLAIN WALL PIPES AND FITTINGS

Typical PVC-U DWV Rubber Ring Joint shown by above extract copy of Figure 7.1 from AS/NZS1260.

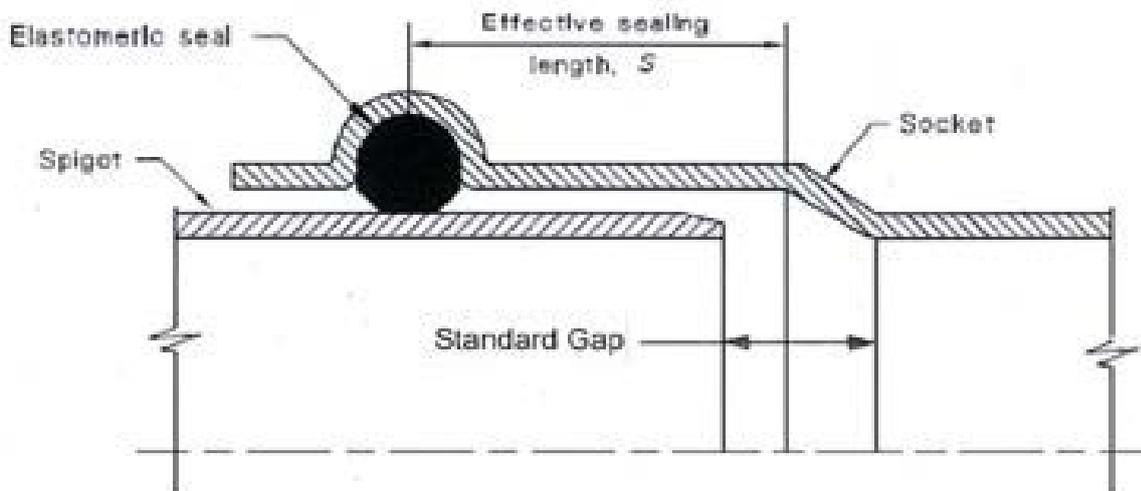
Adjusted Figure 7.1 from AS/NZS1260 showing the "Standard Gap" that is defined in the following Table:

NOMINAL DIAMETER DWV PIPE	STANDARD GAP (mm)		
	ABSOLUTE MINIMUM <sub>1</sub>	MINIMUM <sub>2</sub>	MAXIMUM <sub>2</sub>
100mm	15	45	48
150mm	20	45	51
225mm	25	77	85
300mm	25	55	63

1. The Absolute Minimum Standard Gap is based on the pipes ability to thermally react and/or be affected by reactive soil movement and close up the Minimum Standard Gap. Gaps smaller than the Absolute Minimum Standard Gap are not acceptable
2. The Minimum and Maximum Standard Gaps from Pipe Manufacturer. Gaps greater than the Maximum Standard Gap are not acceptable.

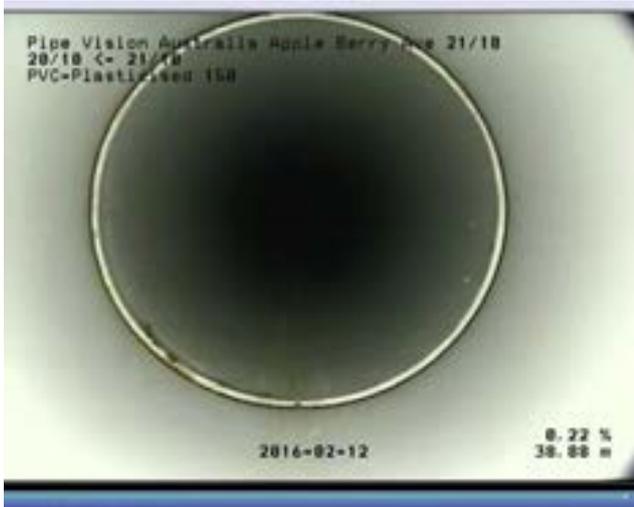
FIG A5.7: Example of a well constructed joint – acceptable

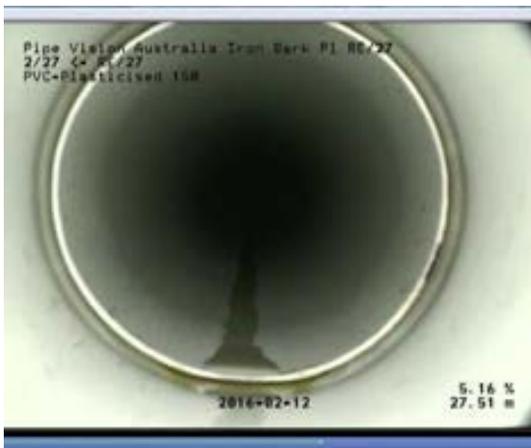
FIG A5.8: Example of excessive width at a joint - not acceptable

A note while watching the CCTV footage to assist in the determination of a wide joint, the camera normally produces a significant “bump” when the camera traverses over it.

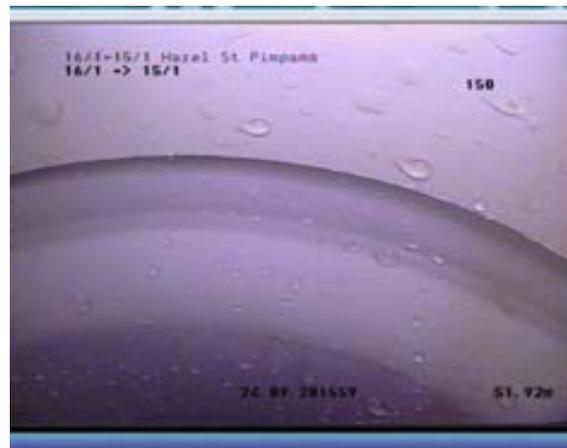
FIG A5.9: Example of excessive width at a joint - not acceptable

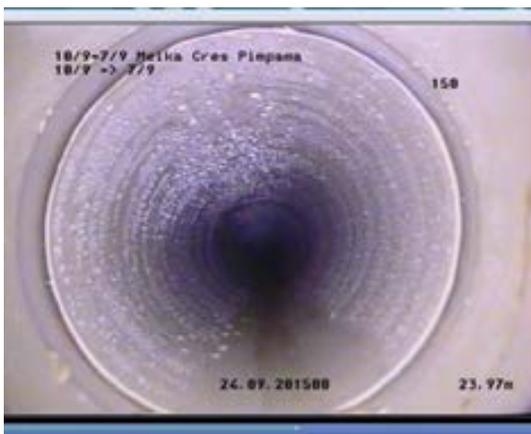
FIG A5.10: Example of excessive gap at a coupling - not acceptable

The required gap width for various coupling types are noted on the applicable SEQ Code standard drawings.

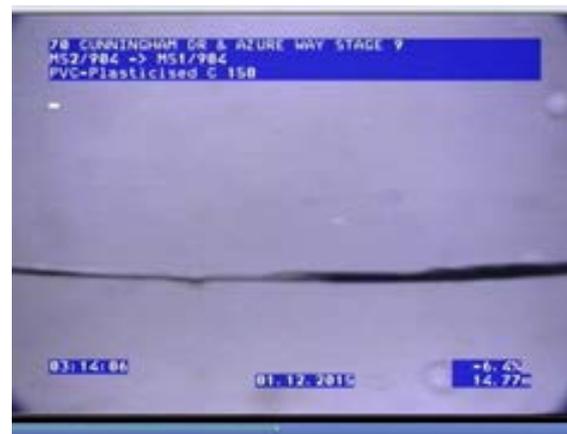
FIG A5.11: Example of no gap at a coupling - not acceptable

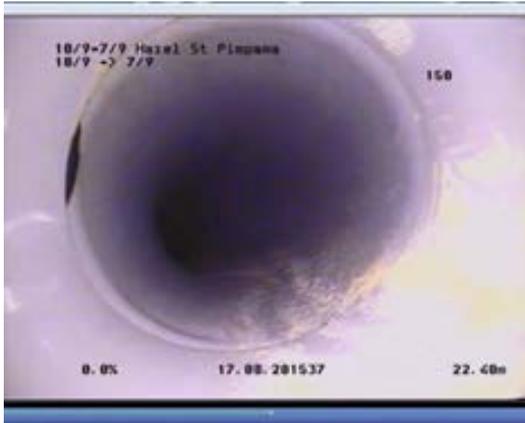
FIG A6.1: Example of an obstruction (rolled rubber) – not acceptable

The *Conduit Inspection Reporting Code WSA05* states obstructions within a pipe or junction is not acceptable. Obstructions of any size within pipes or junctions are not acceptable under any circumstance.

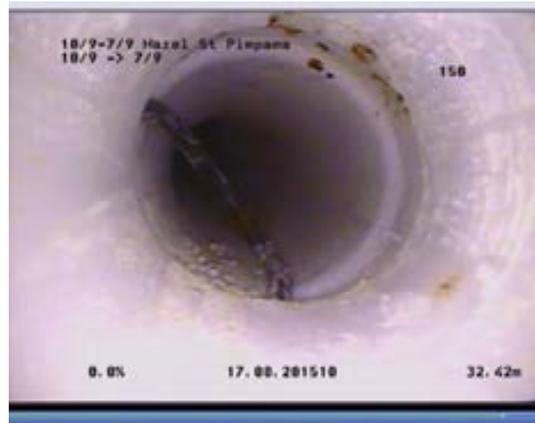
FIG A6.2: Example of an obstruction (rolled rubber) – not acceptable

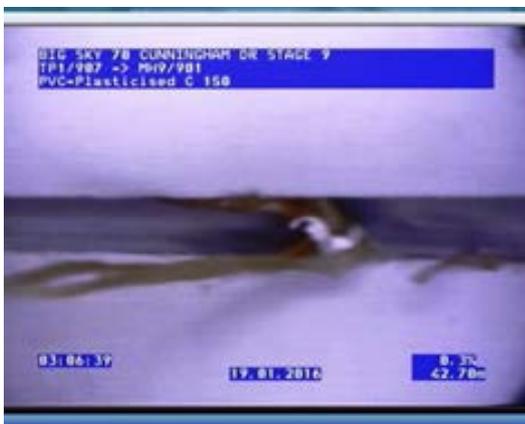
FIG A6.3: Example of an obstruction within a joint – not acceptable

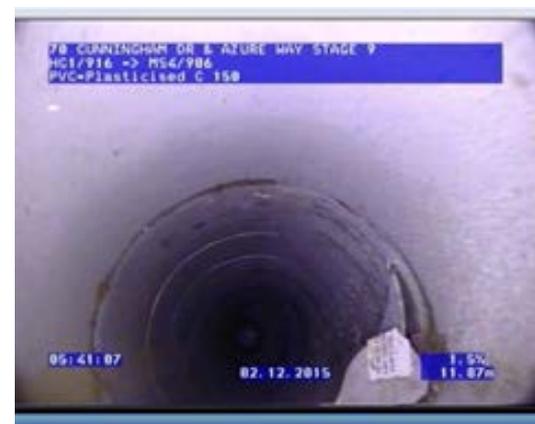
FIG A6.4: Example of an obstruction within a pipe – not acceptable

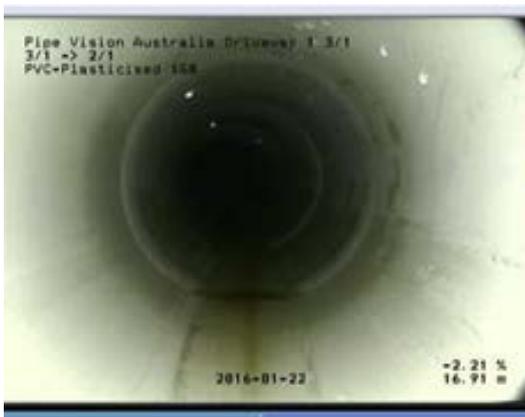
FIG A7.1: Example of minor ponding within a pipe – acceptable

The *Conduit Inspection Reporting Code WSA05* states acceptable water levels within a pipe. Water levels greater than those stated in the *Conduit Inspection Reporting Code WSA05* are not acceptable under any circumstance.

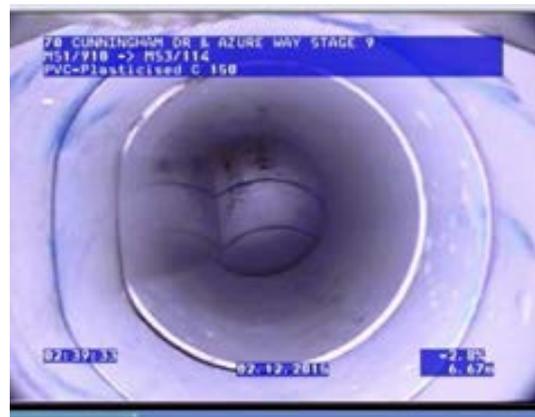
FIG A7.2: Example of minor ponding within a house junction – not acceptable

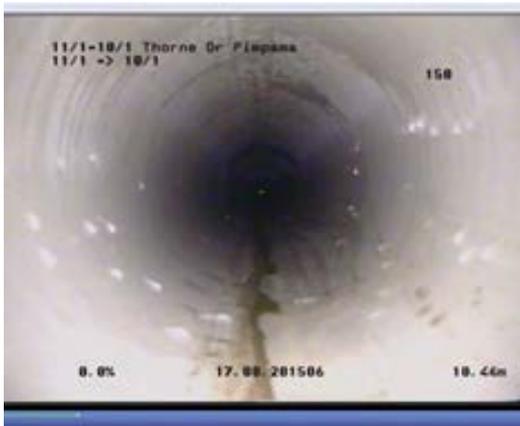
FIG A8.1: Example of a clean pipe – acceptable

All new work must be sufficiently cleaned prior to CCTV being undertaken and to handover to Unitywater. This allows all the pipes, joints, junctions and maintenance structures to be inspected using CCTV. Debris left in the new work also has the potential to create a blockage somewhere in the sewerage network and ultimately could damage pumps at pump stations.

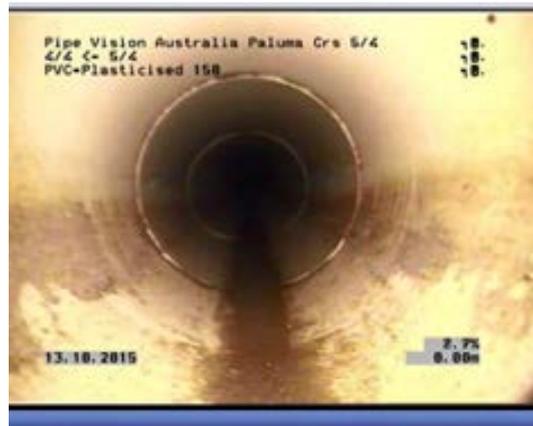
FIG A8.2: Example of a not clean pipe – not acceptable

The deposits shown in FIG A8.2 are only acceptable for the last 10m maximum at the temporary plug at the connection point to existing network. This section of pipe shall be emptied by the Contractor prior to the CCTV investigations, but due to some silt possibly entering the new works during the construction, this section will not be able to be cleaned thoroughly but will be deemed acceptable only to the extent as shown in FIG A8.2 (no large deposits accepted). The Contractor must stop as much silt and foreign matter from entering the new works at all times during the construction. Stored new pipes should be cleaned inside prior to installation, and end caps or similar should be used on all exposed open ends of pipes within the trench, and silt fencing installed around maintenance structures during the construction.

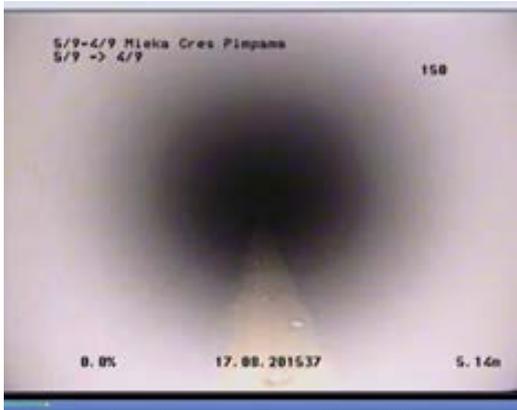
FIG A8.3: Example of a minor deposits at the invert – acceptable

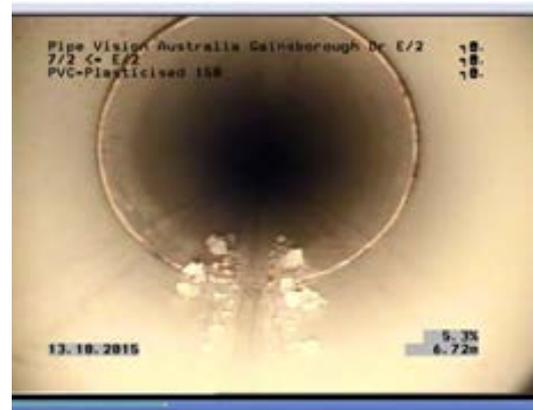
FIG A8.4: Example of a moderate deposits at the invert – not acceptable

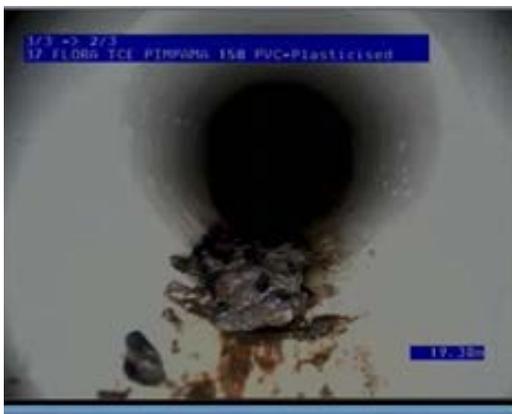
FIG A8.5: Example of a major deposits at the invert – not acceptable

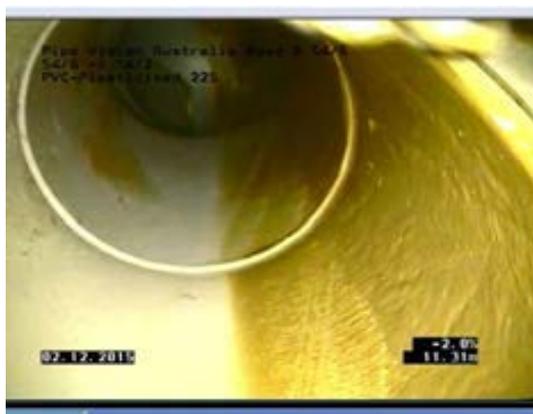
FIG A8.6: Example of a deposits in a junction – not acceptable

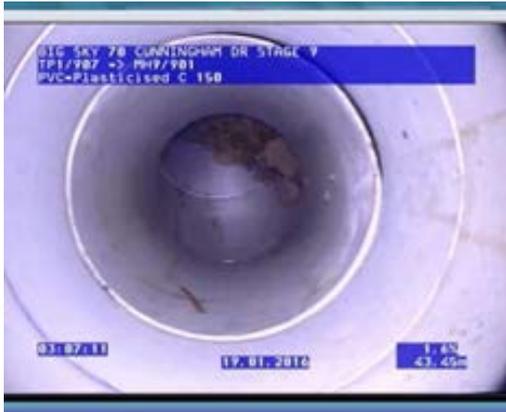
FIG A8.7: Example of a deposits in a junction – not acceptable.
