This guide has been produced to assist Contractors and Consultants (in particular the RPEQ qualified Consulting Engineer for the Development) in arranging for the correct acceptance tests to be completed on all new works.

What works require CCTV

CCTV Submission Requirements

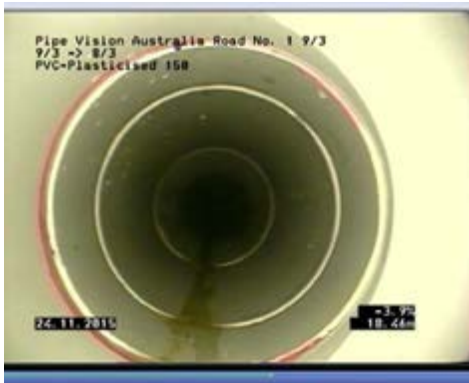
FIG A1.1: Example of good quality footage –acceptable

All CCTV inspection is to be clear and sharp so that review of the newly constructed works can be completed. CCTV inspection that is of poor resolution, out of focus, and/or has poor lighting is unacceptable. This type of footage will be rejected, and the contractor will be required to have the inspection completed again at their cost.

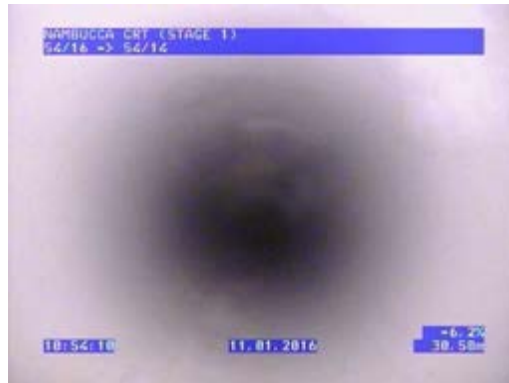
FIG A1.2: Example of poor quality footage – not acceptable

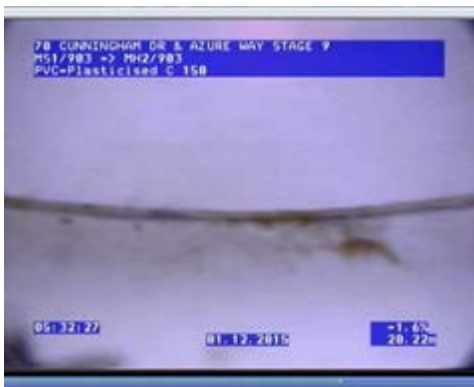
FIG A1.3: Example of poor quality footage of a joint - not acceptable

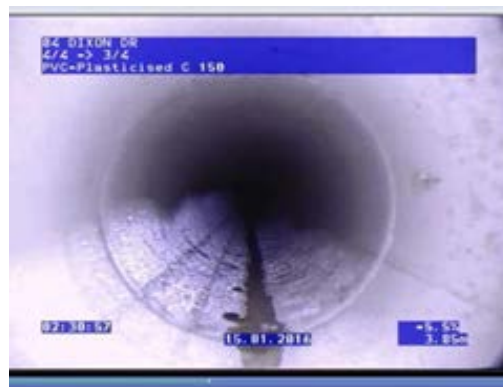
FIG A1.4: Example of poor quality footage of a joint - not acceptable

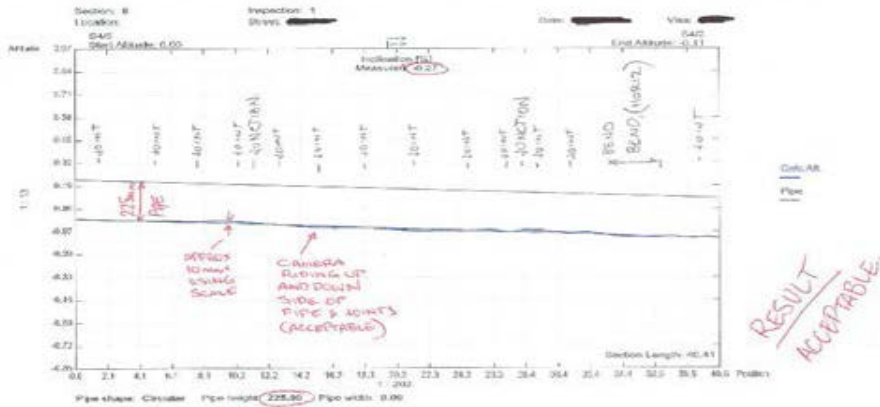
FIG A3.1: Example of how to review an inclination report – pipe acceptable

The SEQ Code (Amendment to WSA02) requires the CCTV inclinometer to be accurate to $\pm 1\%$ (*). The consulting engineer (RPEQ) for the development will determine from the CCTV inclination report and any survey information (as constructed information) whether the longitudinal grade between maintenance structures conform with the acceptable tolerances and the relevant tables in WSA02 adjusting to suit the inclinometer accuracy. This cannot be determined by the invert levels provided in the as constructed survey information at each maintenance structure, but can be determined where the as constructed survey information provides progressive construction levels along the pipe at suitable intervals and at the top of each junction.

Description	Approved Design Grade	Design with inclinometer Accuracy (*)	Inclination Grade	Grade Tolerance	Acceptable (Y/N)	Comment
Line 1/22 – 12/15	5.7%	4.7 % to 6.7%	5.8%		Y	
Line 1/22 – 12/15	5.7%	4.7 % to 6.7%	7.0%	$\pm 20\%$	Y	Review considered accuracy of inclinometer plus tolerance
Line 1/22 – 12/15	5.7%	4.7 % to 6.7%	Varies due to extra vertical bend being installed	$\pm 20\%$	N	Permissible change required for bend and change of grade
Line 1/22 – 12/15	5.7%	4.7 % to 6.7%	12.5%	$\pm 20\%$	N	Permissible change required for change of grade OR if error with inclination new CCTV required

No backfall is permitted along a pipe but Unitywater will allow for short sections less than 500mm long at joints.

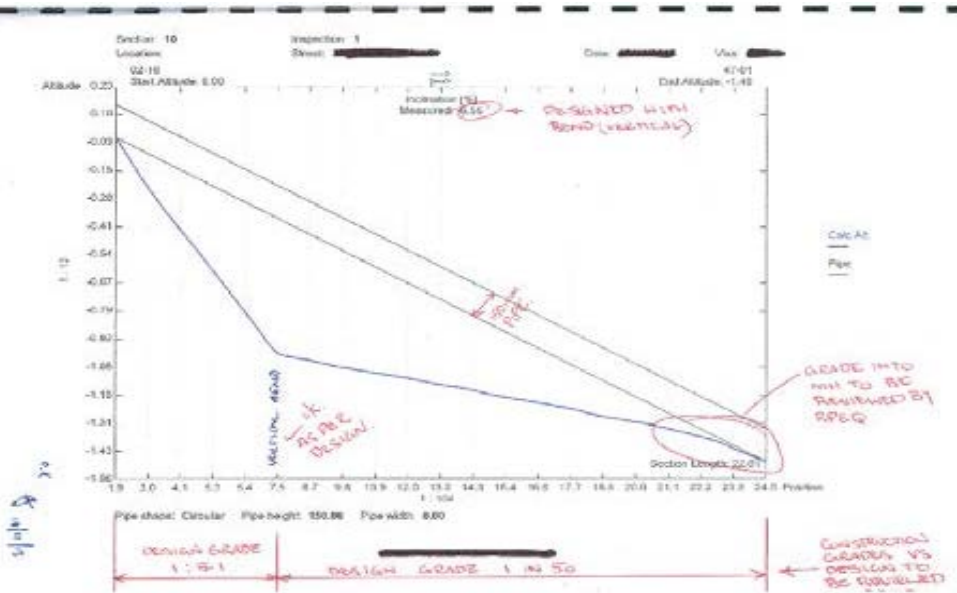
FIG A3.2: Example of how to review an inclination report – consulting engineer (RPEQ) to determine if acceptable

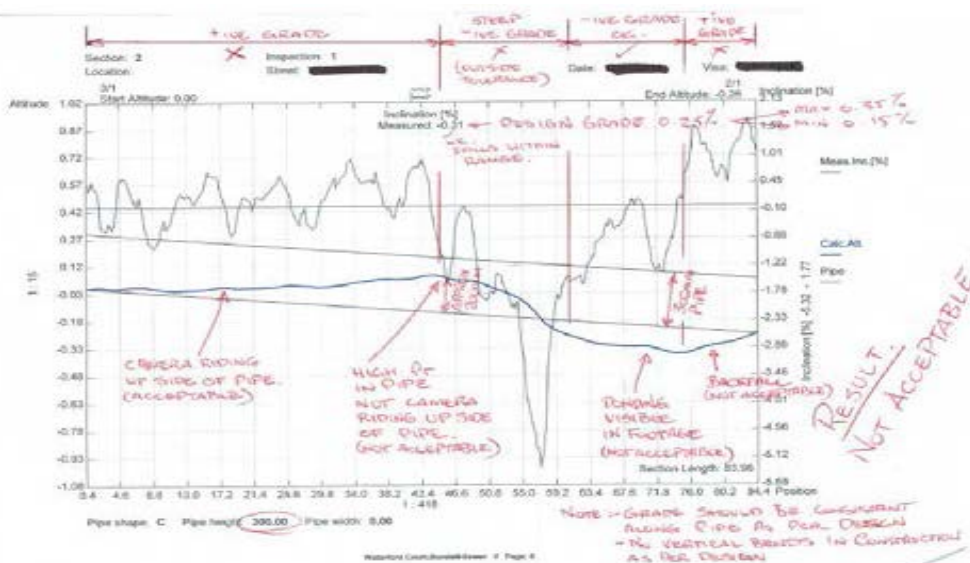
FIG A3.3: Example of how to review an inclination report – pipe not acceptable

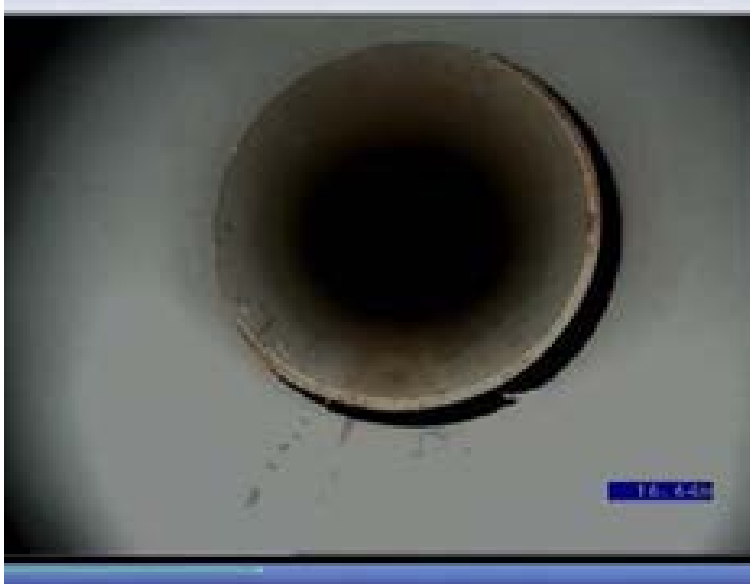
FIG A4.1: Example of collapse at a joint – not acceptable

The *Conduit Inspection Reporting Code WSA05* states a maximum allowable percentage for any collapse in a pipe or junction. Any collapse above this is not acceptable. Unitywater will not accept collapsed pipes or junctions under any circumstance.

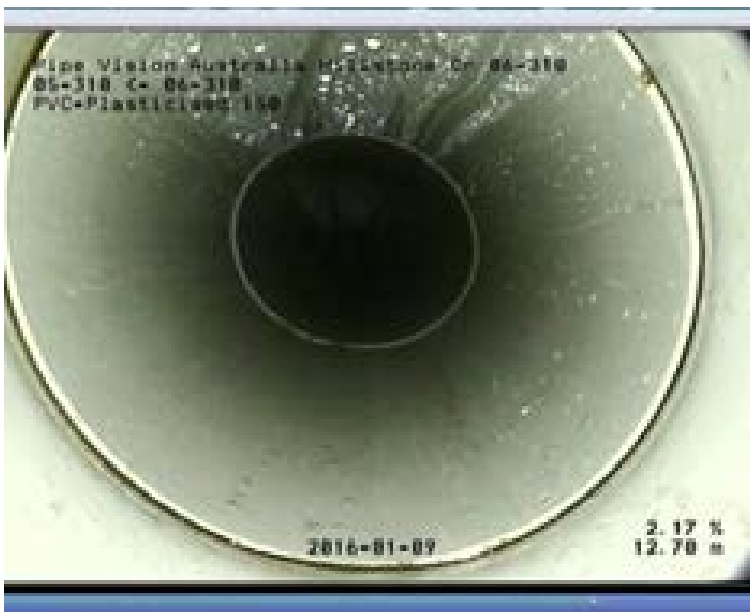
FIG A4.2: Example of deformation (ovality) – not acceptable

The *Conduit Inspection Reporting Code WSA05* also provides the percentage of circumference deformation (ovality) allowable for newly installed sewer mains.

Where circumference deformation (ovality) is evident on the CCTV footage, and a deflection (ovality) test for the line has been completed more than 2 weeks prior to the CCTV investigation, the Contractor shall be required undertake a new ovality test to prove that the joint is acceptable. Where a successful deflection (ovality) test for the line has been completed within 2 weeks prior to the CCTV investigation the consulting engineer (RPEQ) will provide a copy of both test results and include the location in the written report as a non-defect.

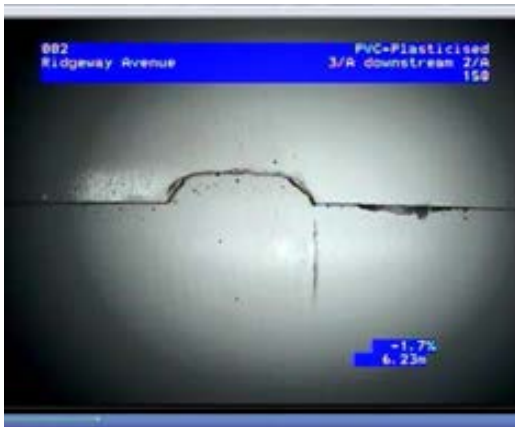
FIG A5.1: Example of a defect at a joint – not acceptable

Unitywater determines any visible damage to the end of pipes as defects, and as such these will need to be repaired by the Contractor. Defects can include, but are not limited to:

- a. cracks, tears, burs, indentations or deformations resulting from bad construction techniques,
- b. end of pipes cut on site not cut square and cleaned in accordance with manufacturer's recommendations,
- c. foreign matter caught within the joint during installation,
- d. rolled rubbers protruding from the joint.

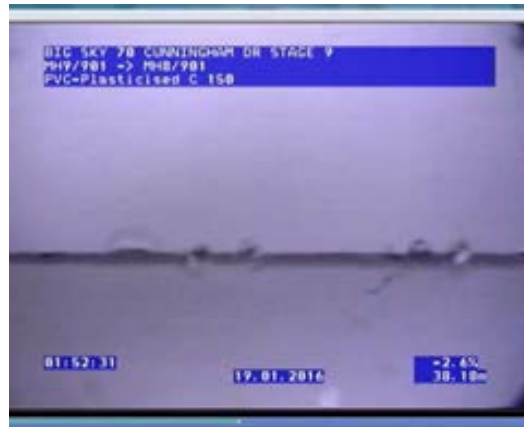
FIG A5.2: Example of defects at a joint – not acceptable

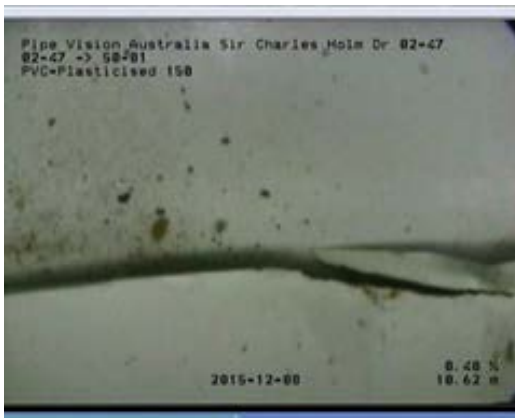
FIG A5.3: Example of a defect at a joint – not acceptable

All manhole/pipe interface joints and rocker pipes must be included in the CCTV investigations so that the joints can be reviewed. The joints and rocker pipes shall be in accordance with the applicable SEQ Code Standard drawing.

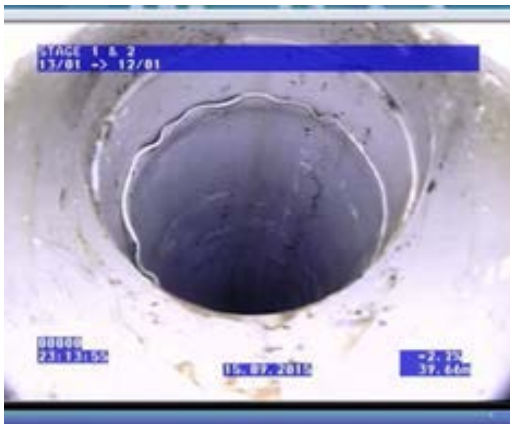
FIG A5.4: Example of a defective house junction – not acceptable FIG A5.5: Example of a defective joint – not acceptable

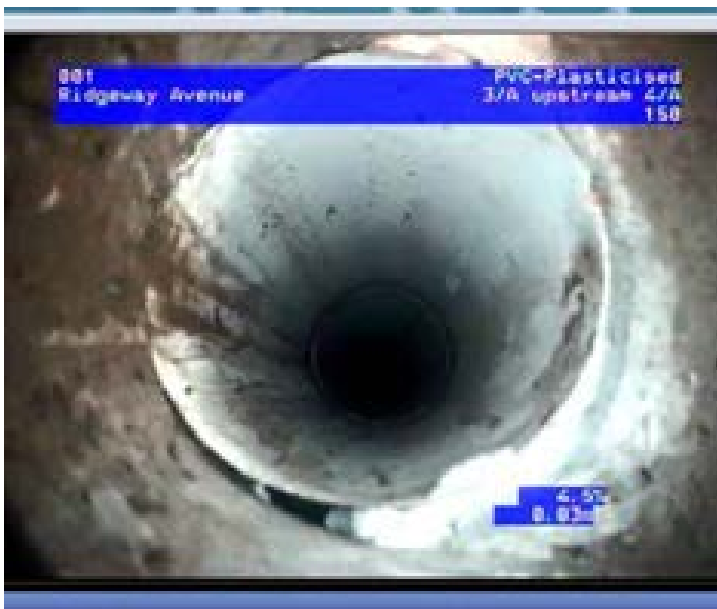
FIG A5.6: Example of a defect at the manhole/pipe interface joint – not acceptable

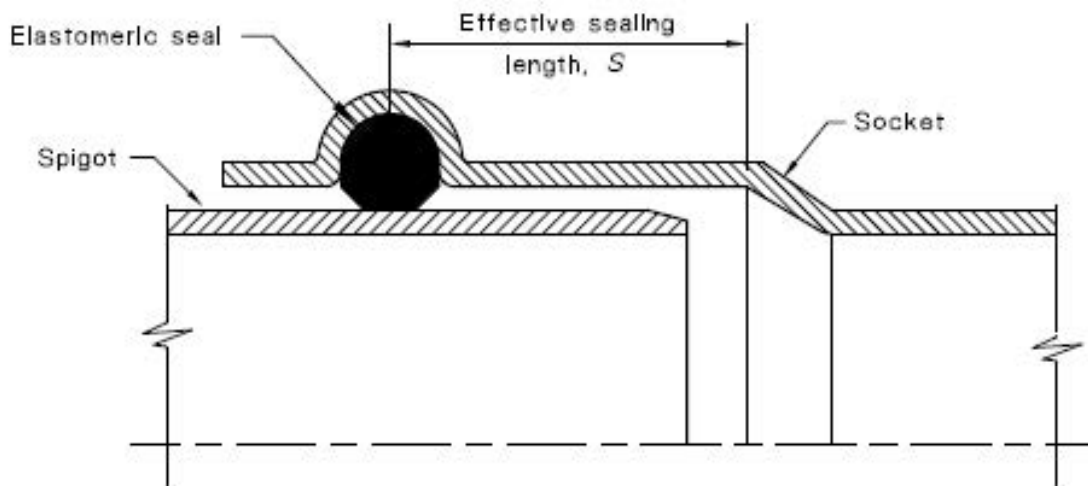
FIGURE 7.1 TYPICAL ELASTOMERIC SEAL JOINT ON PLAIN WALL PIPES AND FITTINGS

Typical PVC-U DWV Rubber Ring Joint shown by above extract copy of Figure 7.1 from AS/NZS1260.

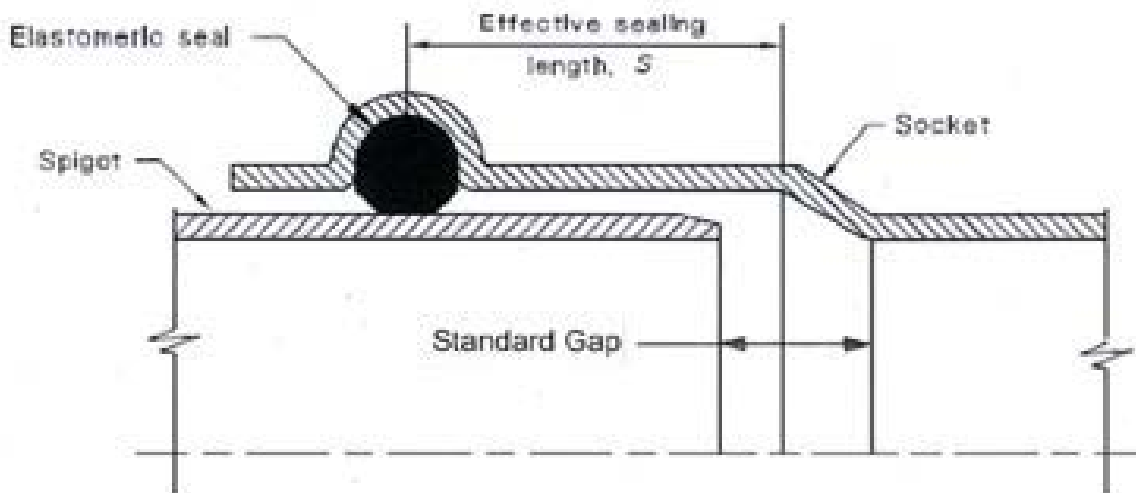
Adjusted Figure 7.1 from AS/NZS1260 showing the "Standard Gap" that is defined in the following Table:

NOMINAL DIAMETER DWV PIPE	STANDARD GAP (mm)		
	ABSOLUTE MINIMUM ₁	MINIMUM ₂	MAXIMUM ₂
100mm	15	45	48
150mm	20	45	51
225mm	25	77	85
300mm	25	55	63

1. The Absolute Minimum Standard Gap is based on the pipes ability to thermally react and/or be affected by reactive soil movement and close up the Minimum Standard Gap. Gaps smaller than the Absolute Minimum Standard Gap are not acceptable
2. The Minimum and Maximum Standard Gaps from Pipe Manufacturer. Gaps greater than the Maximum Standard Gap are not acceptable.

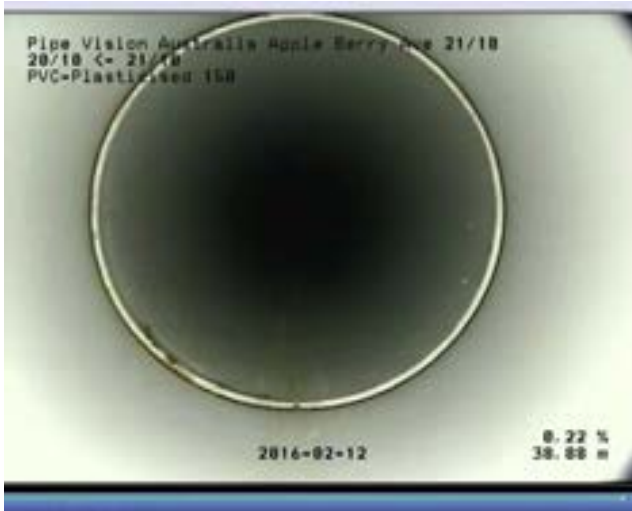
FIG A5.7: Example of a well constructed joint – acceptable

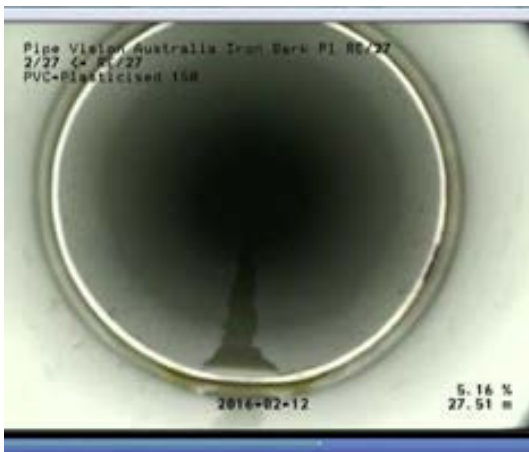
FIG A5.8: Example of excessive width at a joint - not acceptable

A note while watching the CCTV footage to assist in the determination of a wide joint, the camera normally produces a significant “bump” when the camera traverses over it.

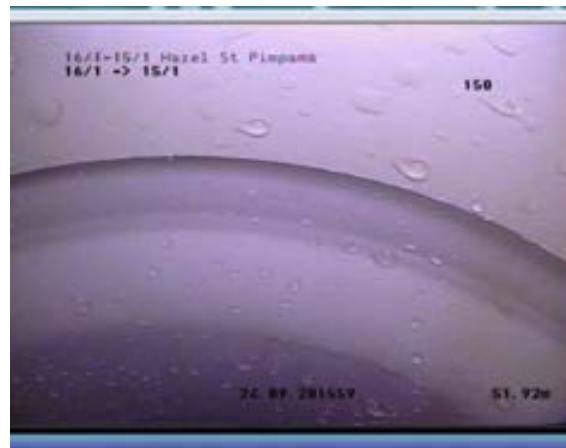
FIG A5.9: Example of excessive width at a joint - not acceptable

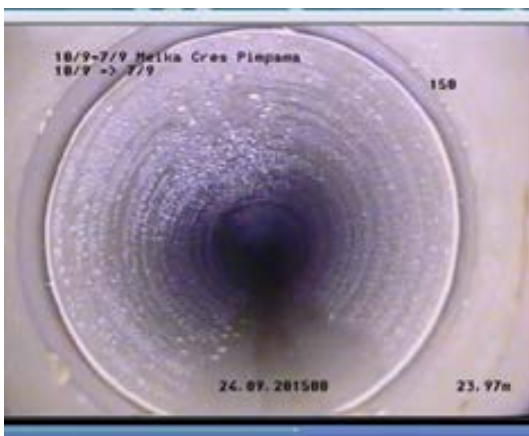
FIG A5.10: Example of excessive gap at a coupling - not acceptable

The required gap width for various coupling types are noted on the applicable SEQ Code standard drawings.

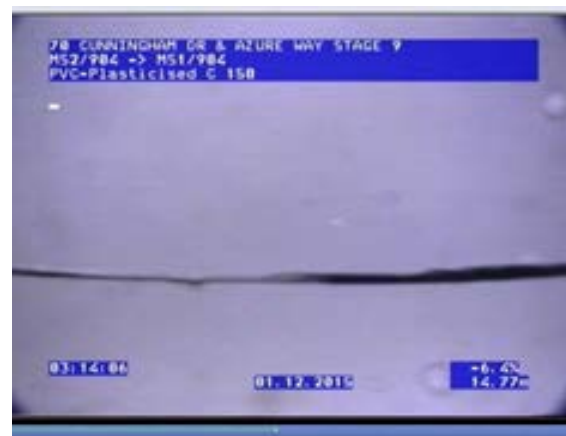
FIG A5.11: Example of no gap at a coupling - not acceptable

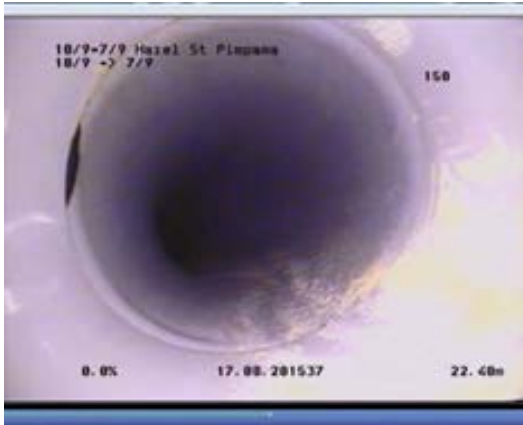
FIG A6.1: Example of an obstruction (rolled rubber) – not acceptable

The *Conduit Inspection Reporting Code WSA05* states obstructions within a pipe or junction is not acceptable. Obstructions of any size within pipes or junctions are not acceptable under any circumstance.

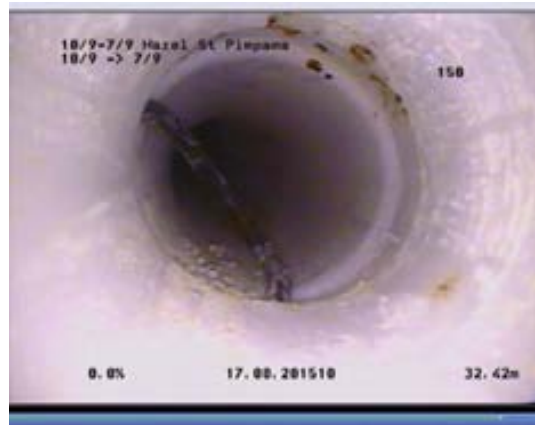
FIG A6.2: Example of an obstruction (rolled rubber) – not acceptable

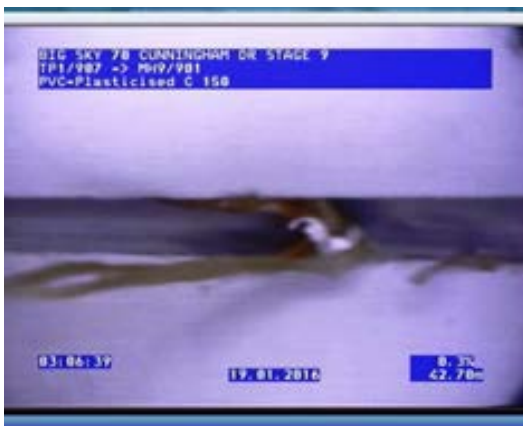
FIG A6.3: Example of an obstruction within a joint – not acceptable

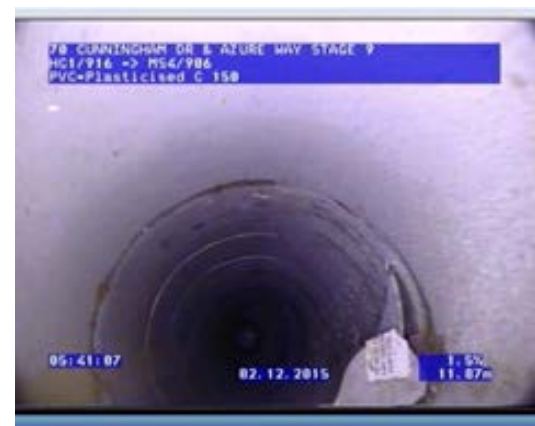
FIG A6.4: Example of an obstruction within a pipe – not acceptable

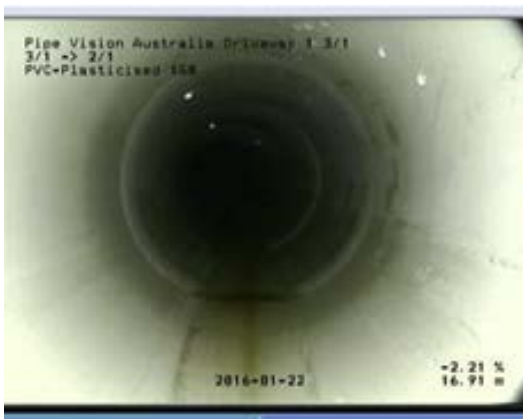
FIG A7.1: Example of minor ponding within a pipe – acceptable

The *Conduit Inspection Reporting Code WSA05* states acceptable water levels within a pipe. Water levels greater than those stated in the *Conduit Inspection Reporting Code WSA05* are not acceptable under any circumstance.

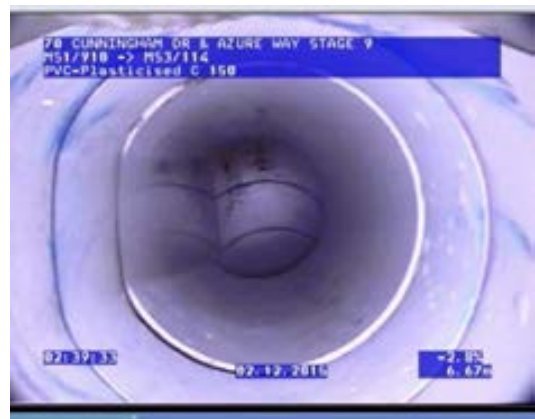
FIG A7.2: Example of minor ponding within a house junction – not acceptable

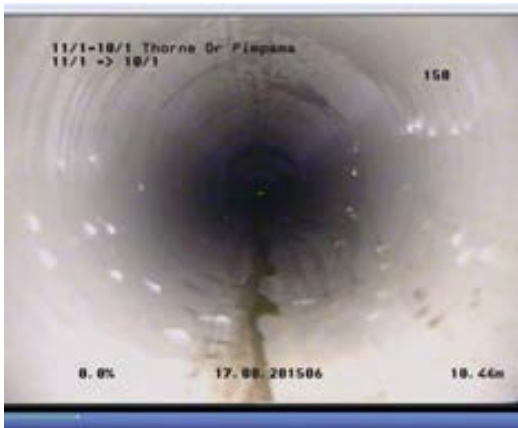
FIG A8.1: Example of a clean pipe – acceptable

All new work must be sufficiently cleaned prior to CCTV being undertaken and to handover to Unitywater. This allows all the pipes, joints, junctions and maintenance structures to be inspected using CCTV. Debris left in the new work also has the potential to create a blockage somewhere in the sewerage network and ultimately could damage pumps at pump stations.

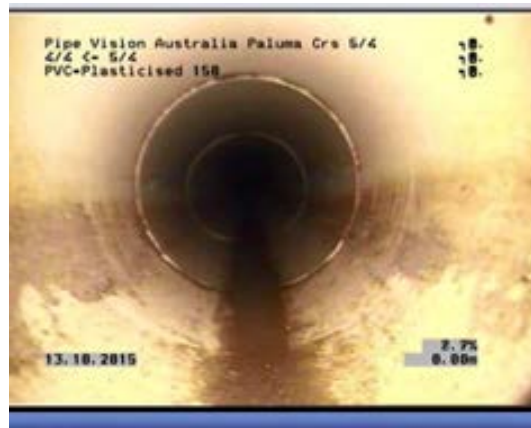
FIG A8.2: Example of a not clean pipe – not acceptable

The deposits shown in FIG A8.2 are only acceptable for the last 10m maximum at the temporary plug at the connection point to existing network. This section of pipe shall be emptied by the Contractor prior to the CCTV investigations, but due to some silt possibly entering the new works during the construction, this section will not be able to be cleaned thoroughly but will be deemed acceptable only to the extent as shown in FIG A8.2 (no large deposits accepted). The Contractor must stop as much silt and foreign matter from entering the new works at all times during the construction. Stored new pipes should be cleaned inside prior to installation, and end caps or similar should be used on all exposed open ends of pipes within the trench, and silt fencing installed around maintenance structures during the construction.

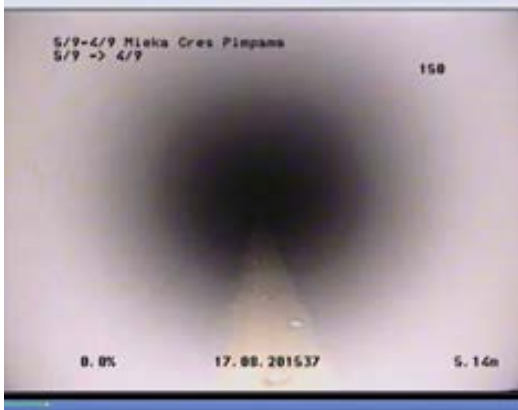
FIG A8.3: Example of a minor deposits at the invert – acceptable

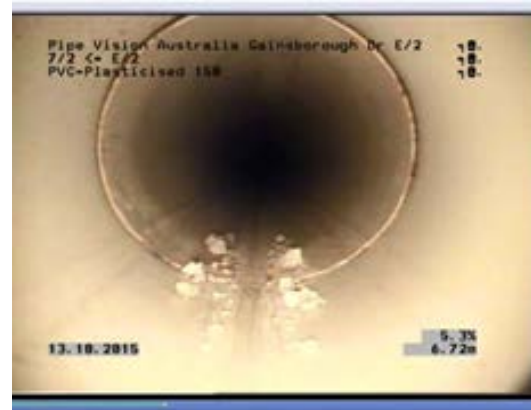
FIG A8.4: Example of a moderate deposits at the invert – not acceptable

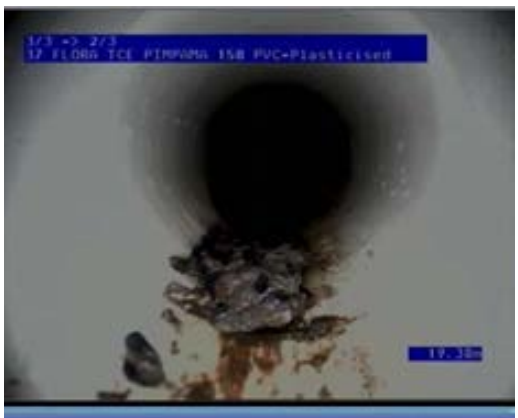
FIG A8.5: Example of a major deposits at the invert – not acceptable

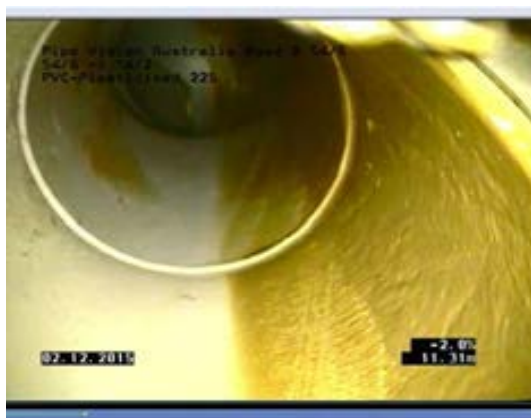
FIG A8.6: Example of a deposits in a junction – not acceptable

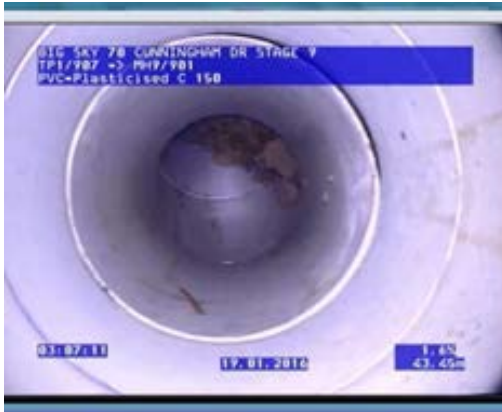
FIG A8.7: Example of a deposits in a junction – not acceptable.
